## Inspection Report

### Minerals Regulatory Program

**Mine Name:** Little Indian  
**Operator Name:** H & H Stone

**Permit number:** S0370117  
**Inspection Date:** June 1, 2007  
**Time:** 1:05-1:20 PM

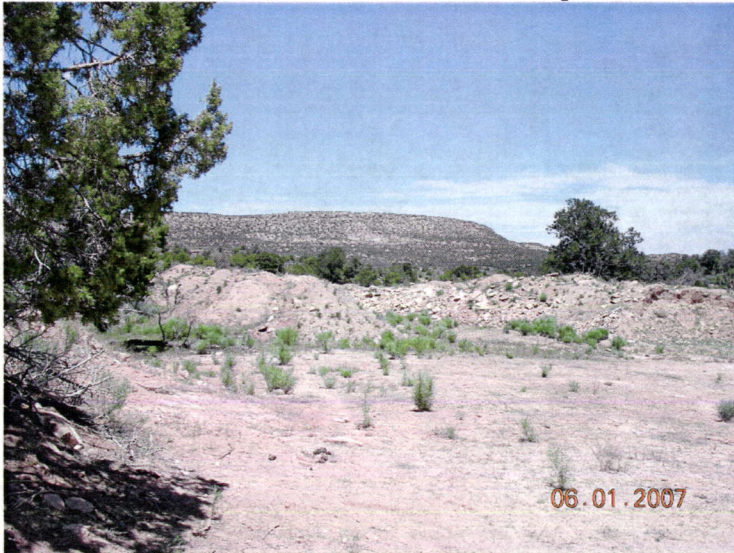
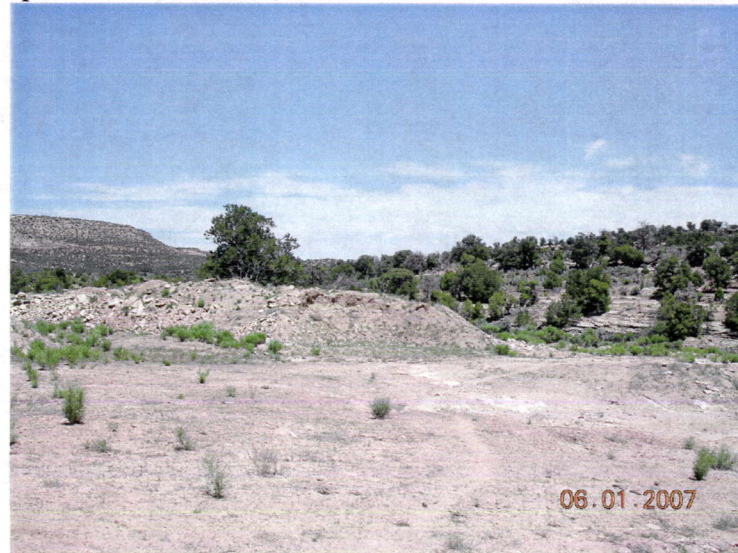
The condition of the site has not changed since I last visited this area on June 13, 2006. As can be seen in Photos 1 and 3, the area on the north side of the quarry still has not been graded. There is also a berm on the southwest side of the quarry where a drainage from an adjacent undisturbed comes in to the area (Photo 2).

**Photo 1.** This picture and Photo 3 make a panorama of the majority of the area that needs to be regraded on the north side of the quarry.

**Photo 3.** See the caption to Photo 1.

Since the operator has not completed grading and seeding, the Division needs to require the operator to submit a reclamation surety. There is not a lot of work remaining, so the majority of the cost would be for mobilization of a small dozer or trackhoe to level out some of the piles of soil and overburden. These areas will also need to be seeded. I suggest that the Division contact a contractor in Monticello to find out how much mobilization would cost.

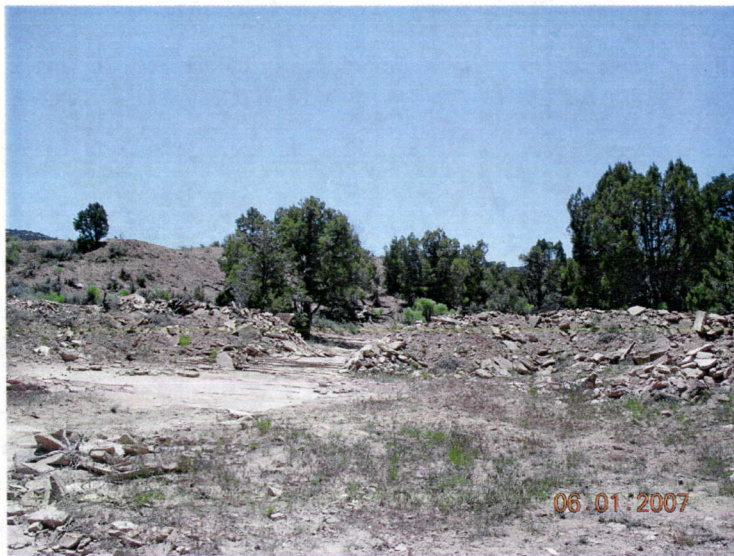
**Photo 2.** Across the center of this picture are shown two berms with a gap between them through which water flows.

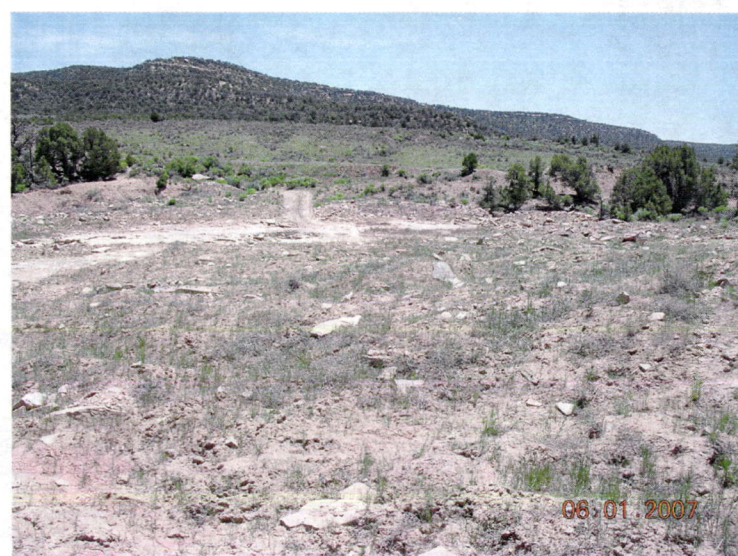
Vegetation is progressing well in the areas that were graded and seeded in 2005 (Photo 4).

**Photo 4.** This is the area that was graded and seeded in 2005. Note the amount of grass.
